MOUNTAIN WATER

and the TOWN

Intermountain Region

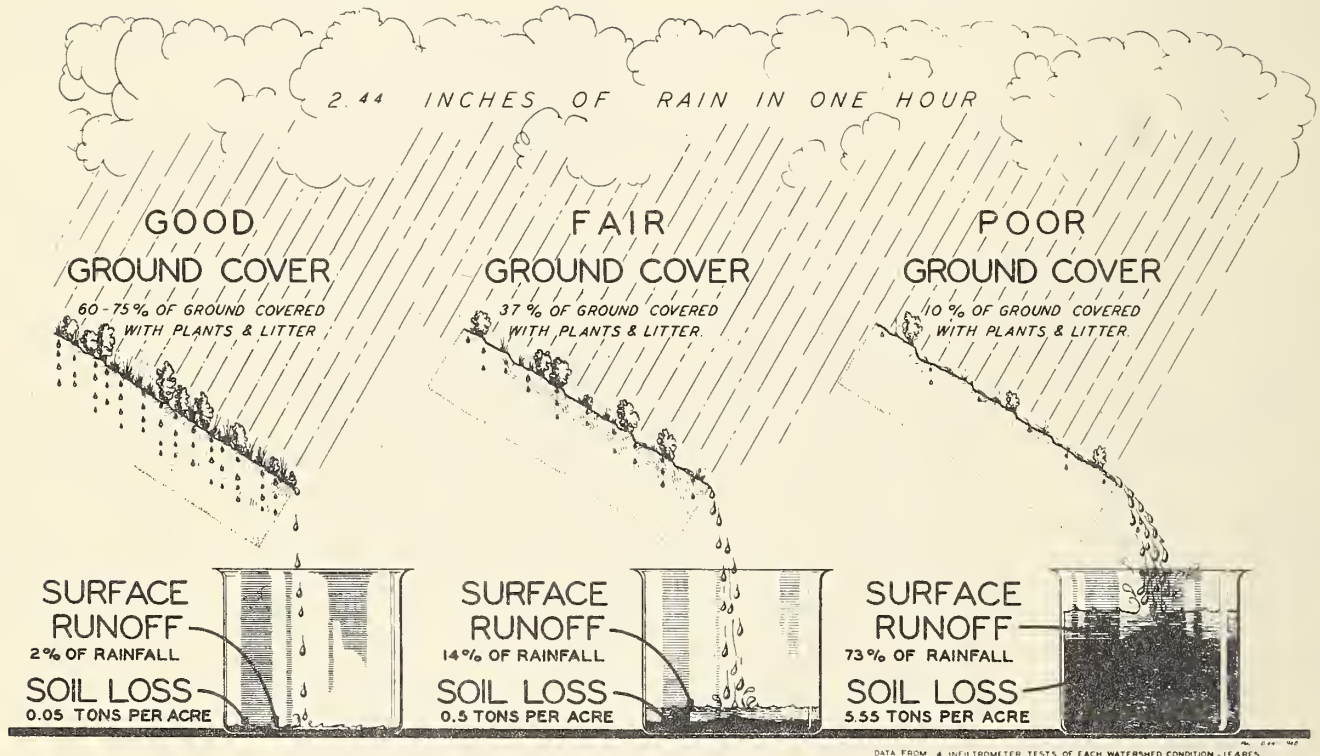
RAINSTORM RUNOFF & EROSION UNDER VARYING WATERSHED CONDITIONS

SUB-ALPINE RANGE, EPHRAIM WATERSHED, UTAH

The chart shown above illustrates what happens when cloudburst rains strike a mountainside well covered with vegetation as compared to a slope that has a poor ground cover. Intense rains beating down on a mountain slope that has been stripped of plants and litter cannot filter through the soil. The water runs off, is lost, and topsoil is lost with it. This is the forerunner of gullies and destructive floods.

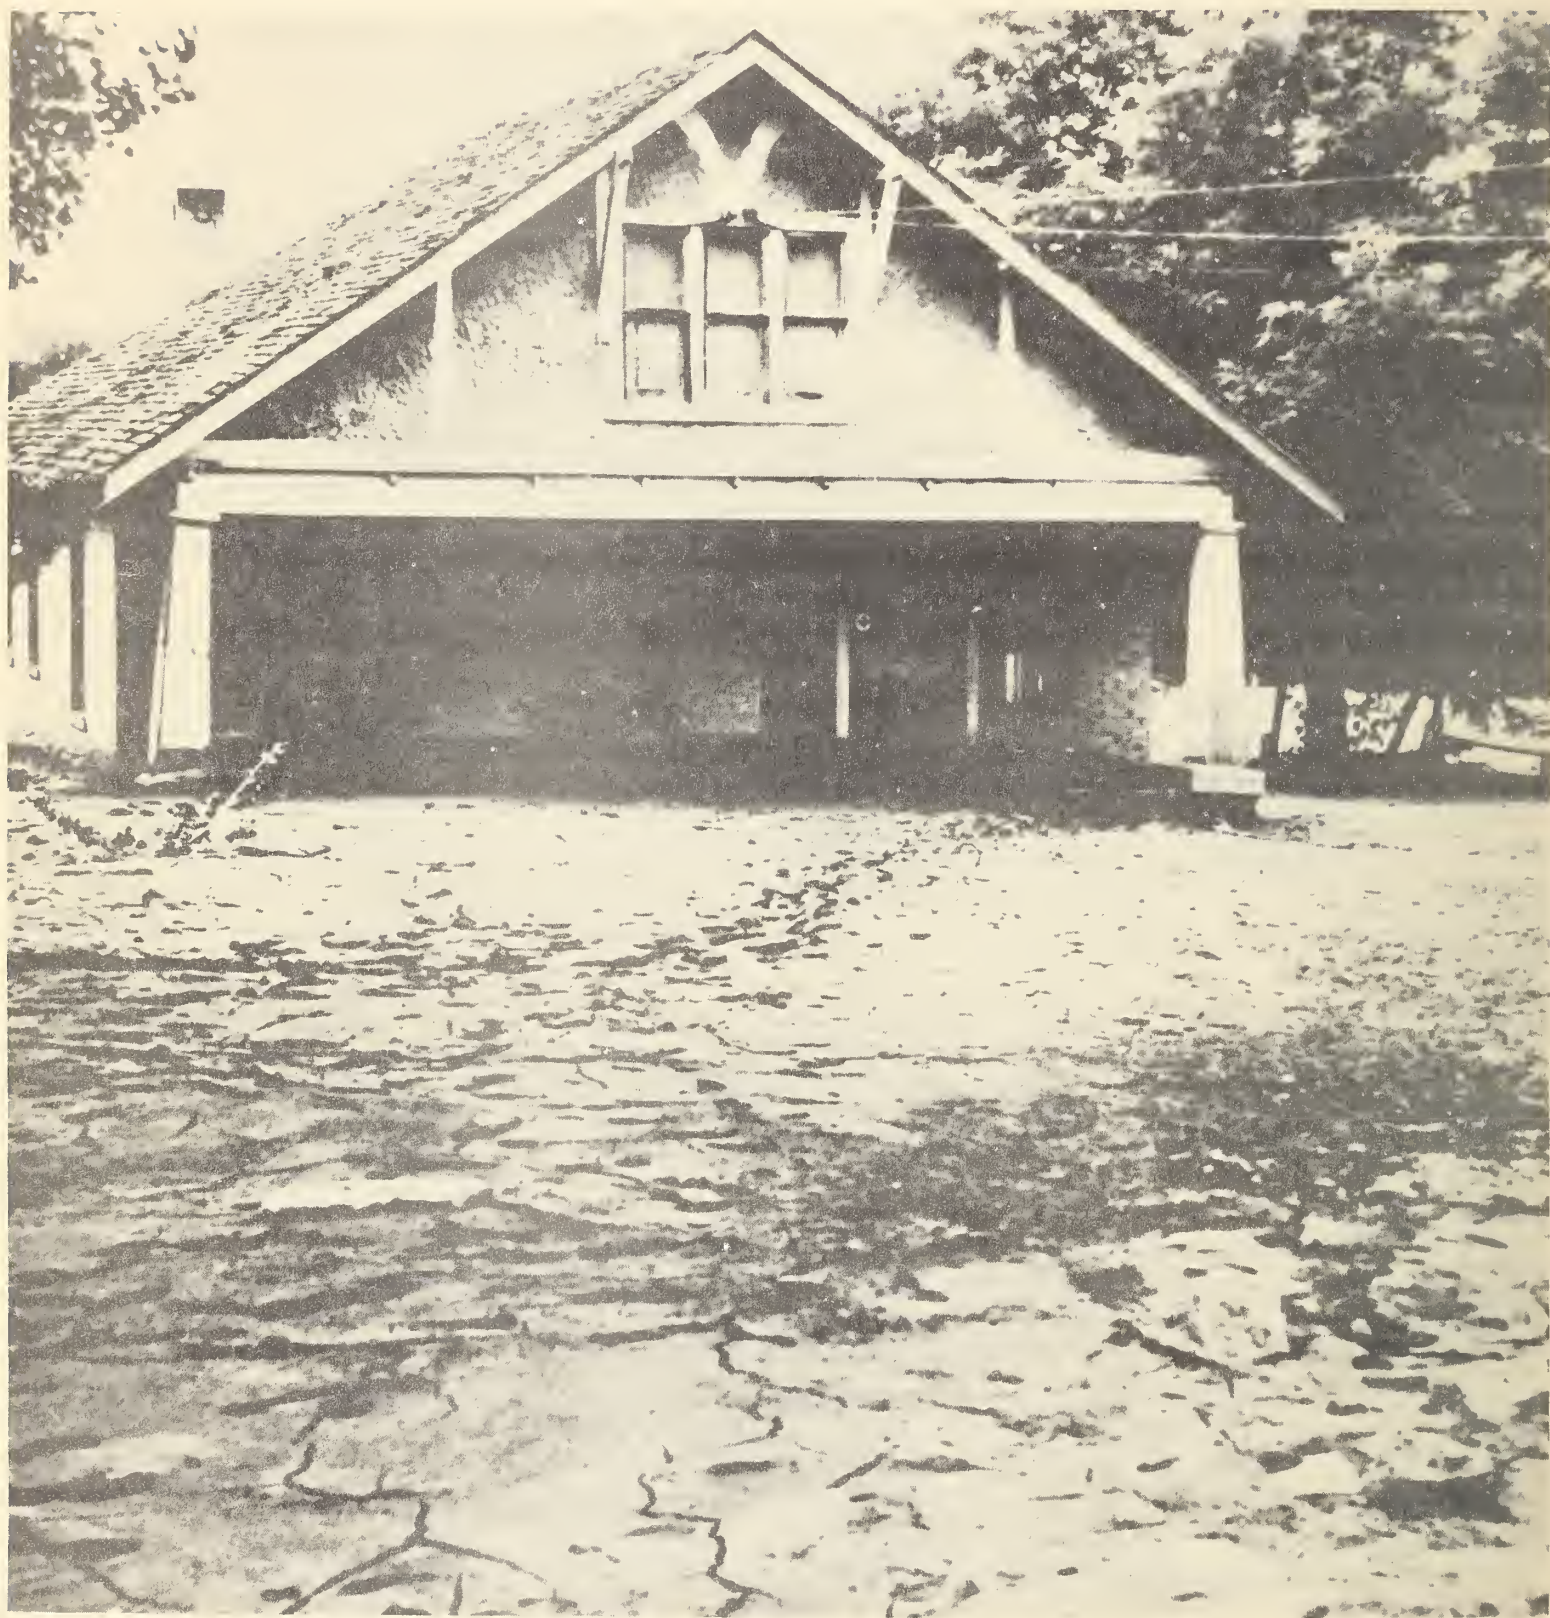
WILLARD, UTAH WATERSHED.

A SUMMER FLOOD VISITS WILLARD.

Following a combination of overgrazing, burning, and overcutting of timber, the first serious mud-rock flood spilled off the Willard Watershed on August 13, 1923. Between 1923 and 1936 a series of disastrous floods from the denuded watershed followed in ruinous succession, resulting in:

DEATH TO TWO WOMEN WHO WERE CRUSHED IN THEIR HOMES
FORTY HOMES DAMAGED OR DESTROYED
MUNICIPAL POWER PLANT COMPLETELY DESTROYED
MUNICIPAL WATER AND IRRIGATION SYSTEMS IMPAIRED
ORCHARDS AND TRUCK GARDENS RUINED
HIGHWAY 91 BLOCKED FOR TWO-WEEK PERIOD
TOTAL LOSSES, TANGIBLE AND INTANGIBLE, MORE THAN
\$500,000.

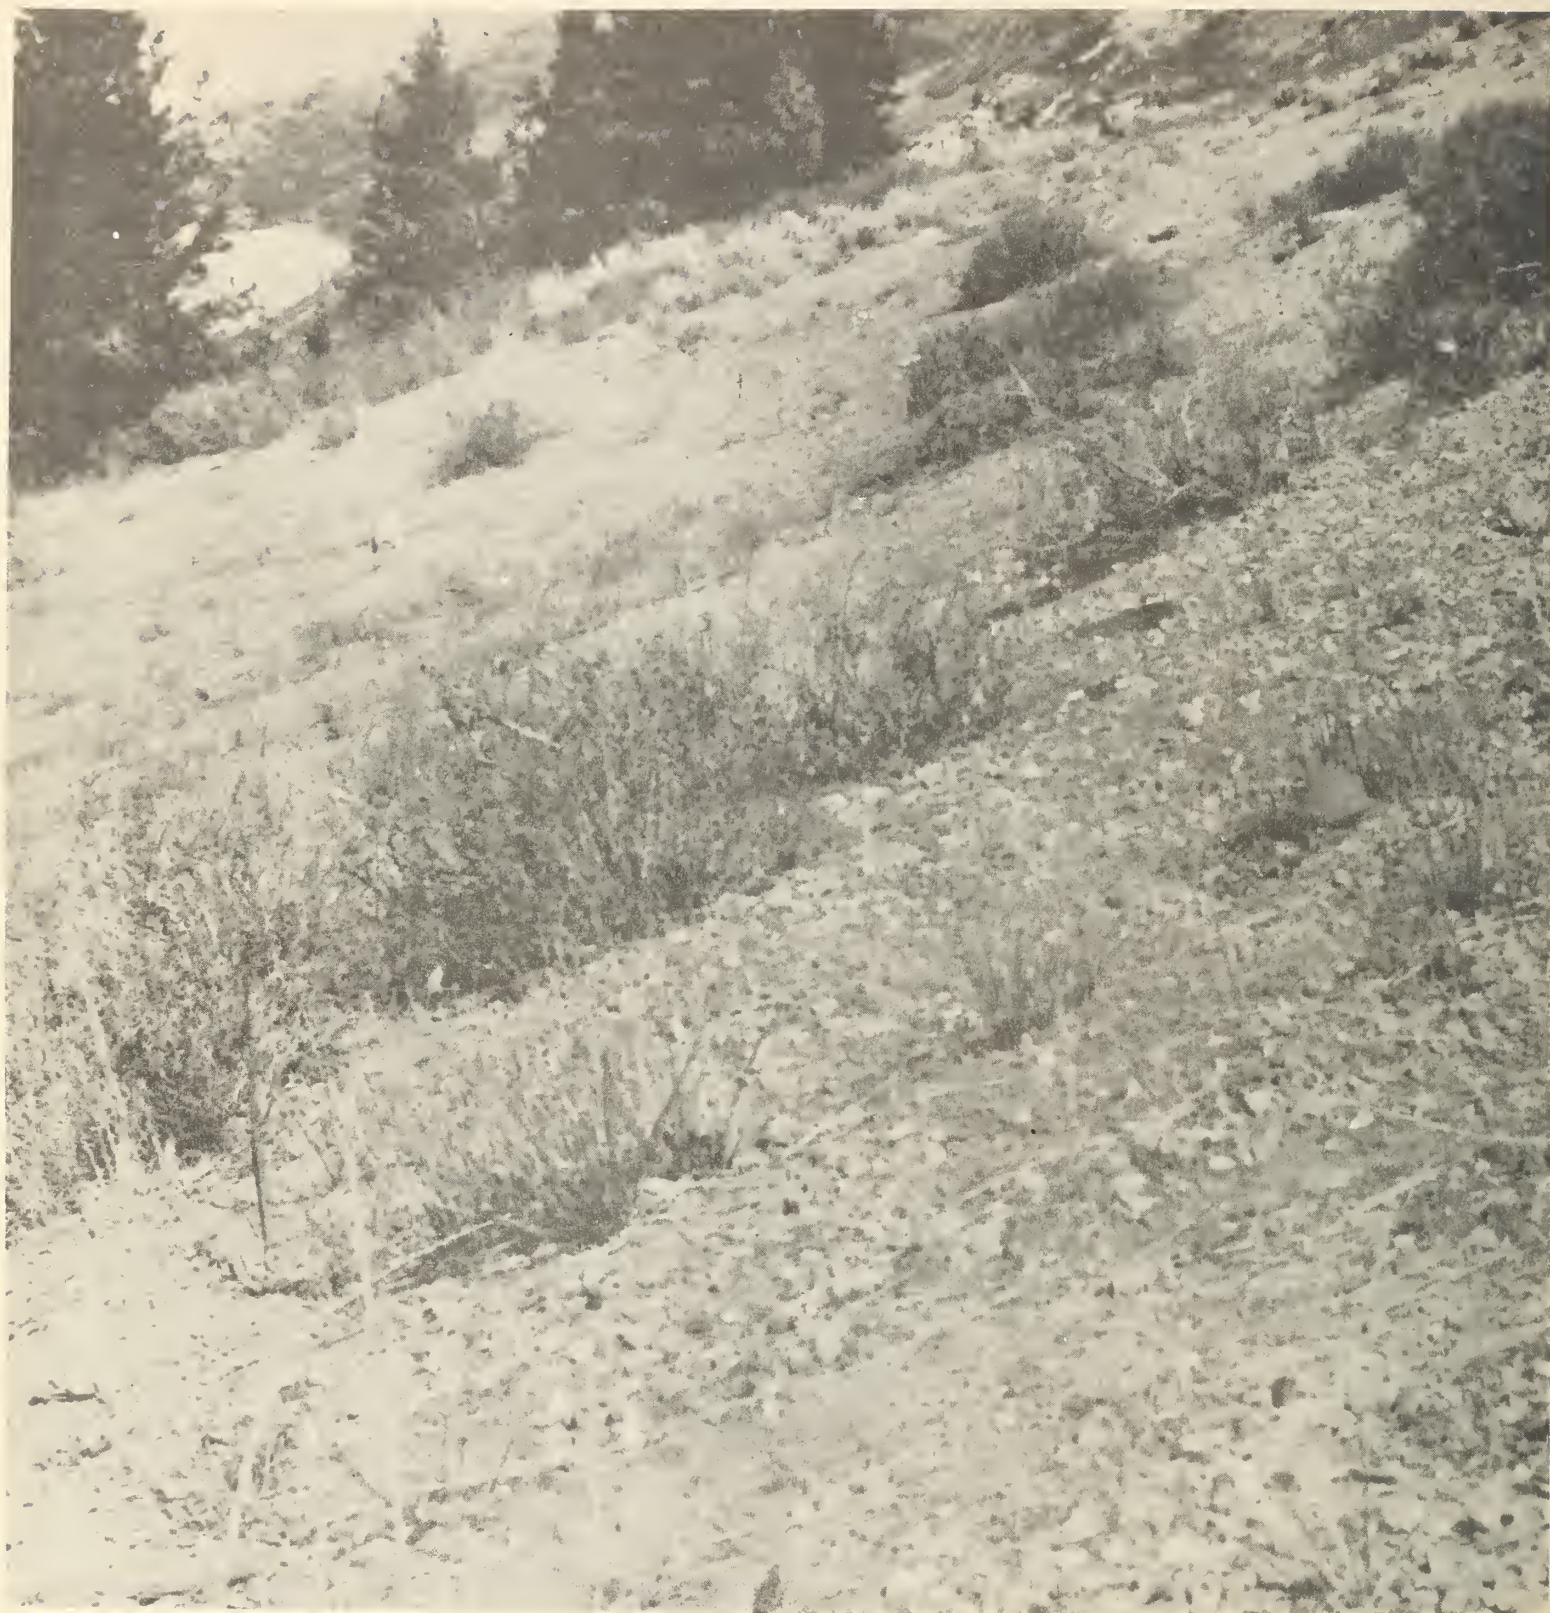
SOIL LAID BARE TO THE STORM.

Once placed in public ownership, the Forest Service contour-terraced, reseeded, and planted trees on the land at a cost of approximately \$100,000. Scars on the watershed have gradually healed and damaging mud-rock flows have not recurred.

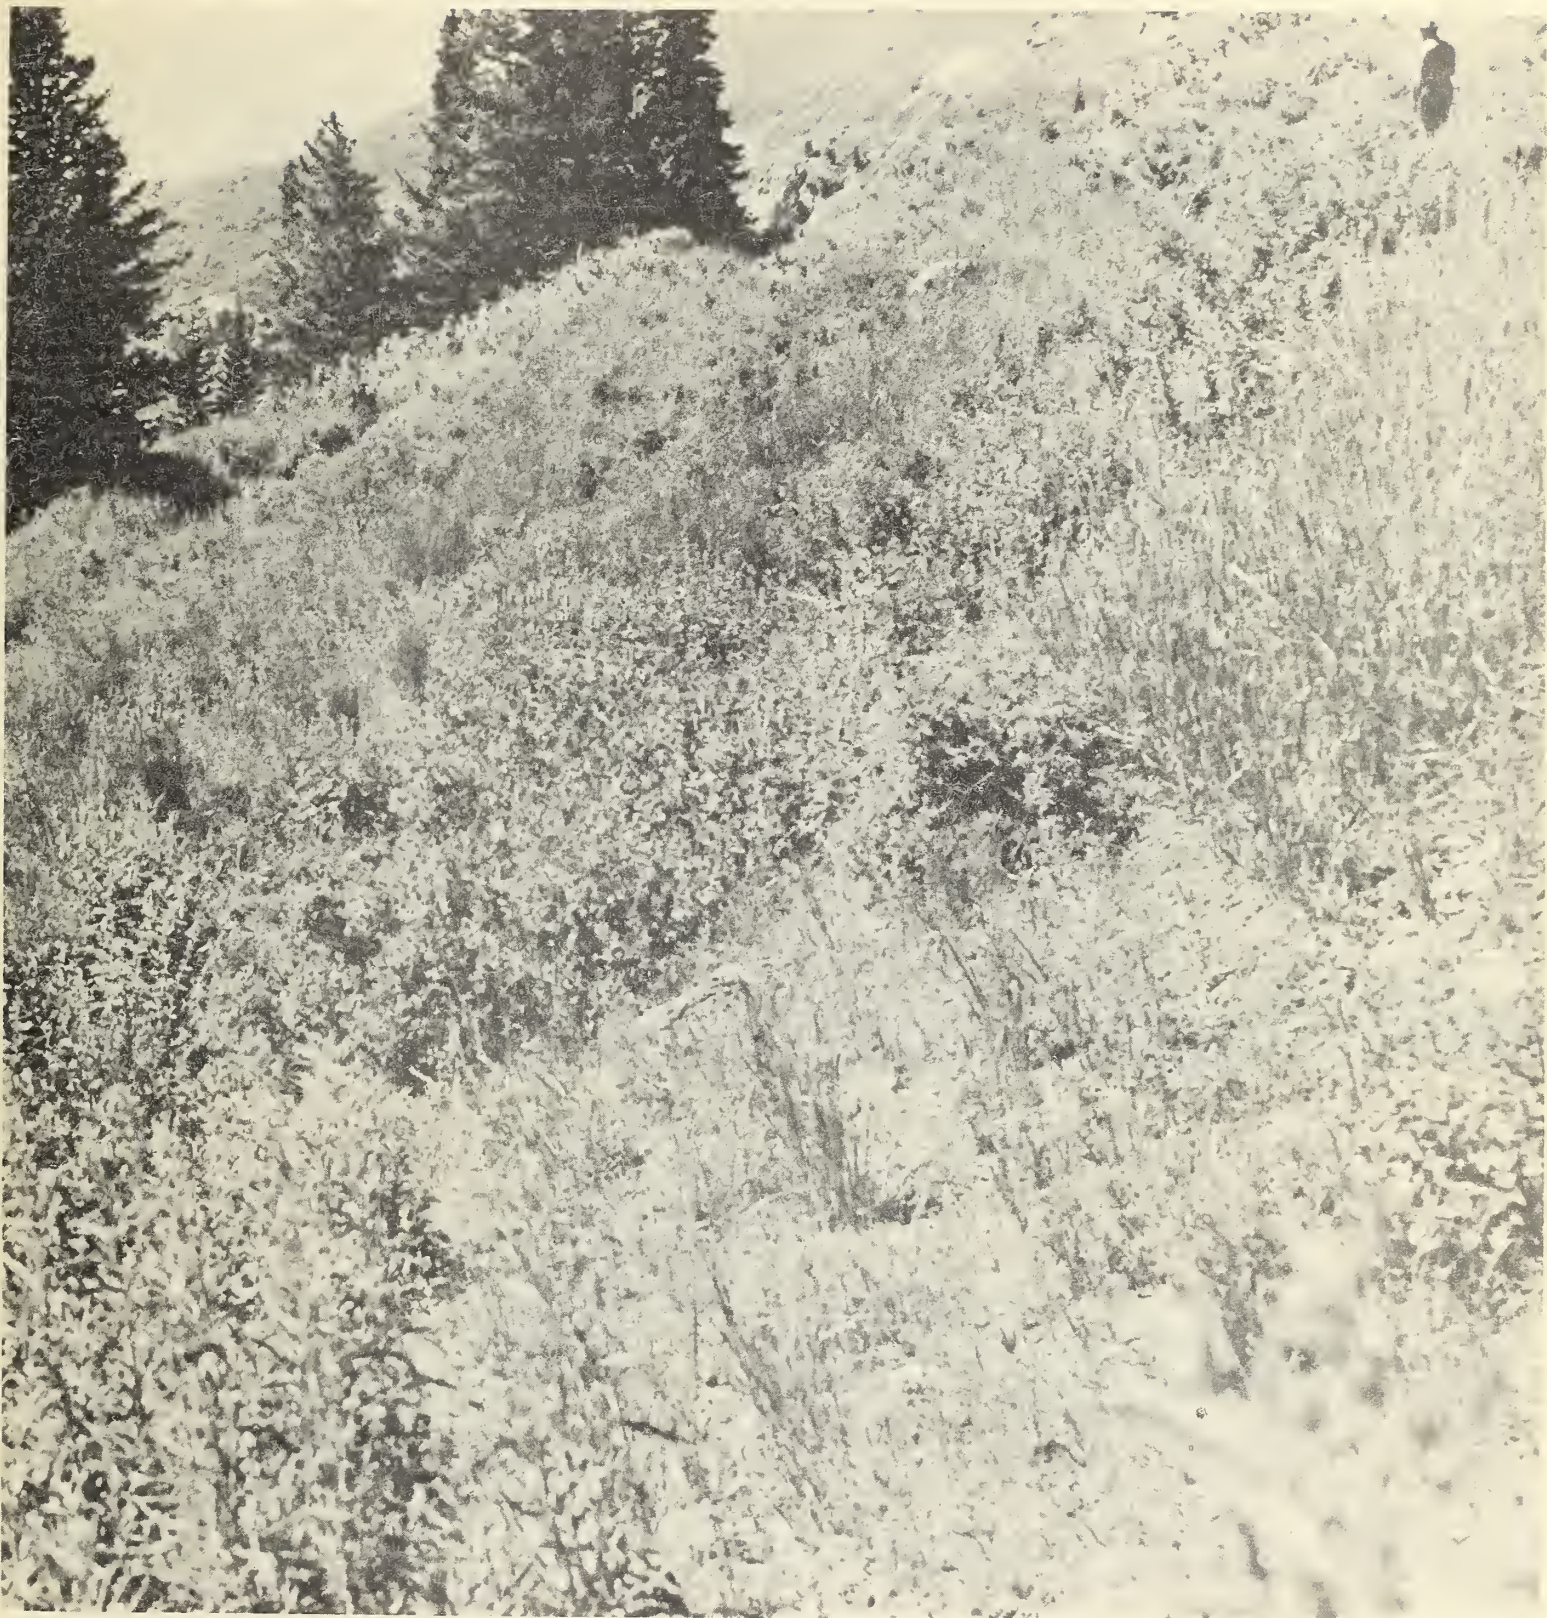
THE SAME HILLSIDE , BUT PLANTS NOW SHIELD THE SOIL .

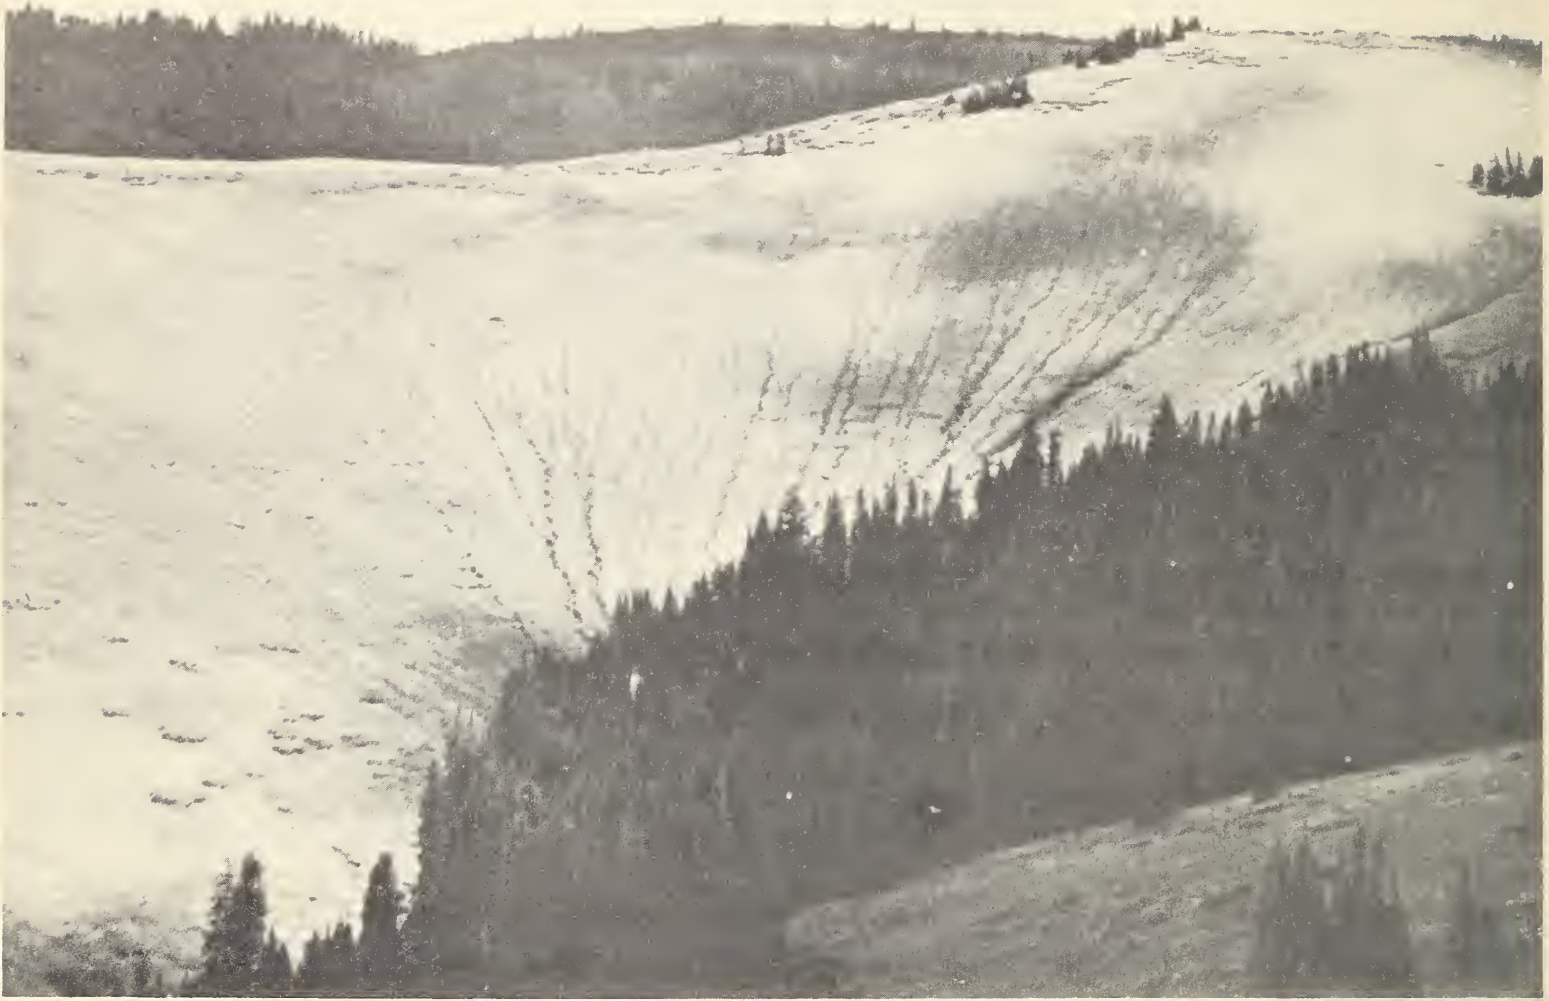
MT. PLEASANT, UTAH WATERSHED.

PLANT COVER WORN THIN --

Overgrazing of the Pleasant Creek watershed in the early days by too many sheep, cattle and horses was held chiefly responsible for the flood.

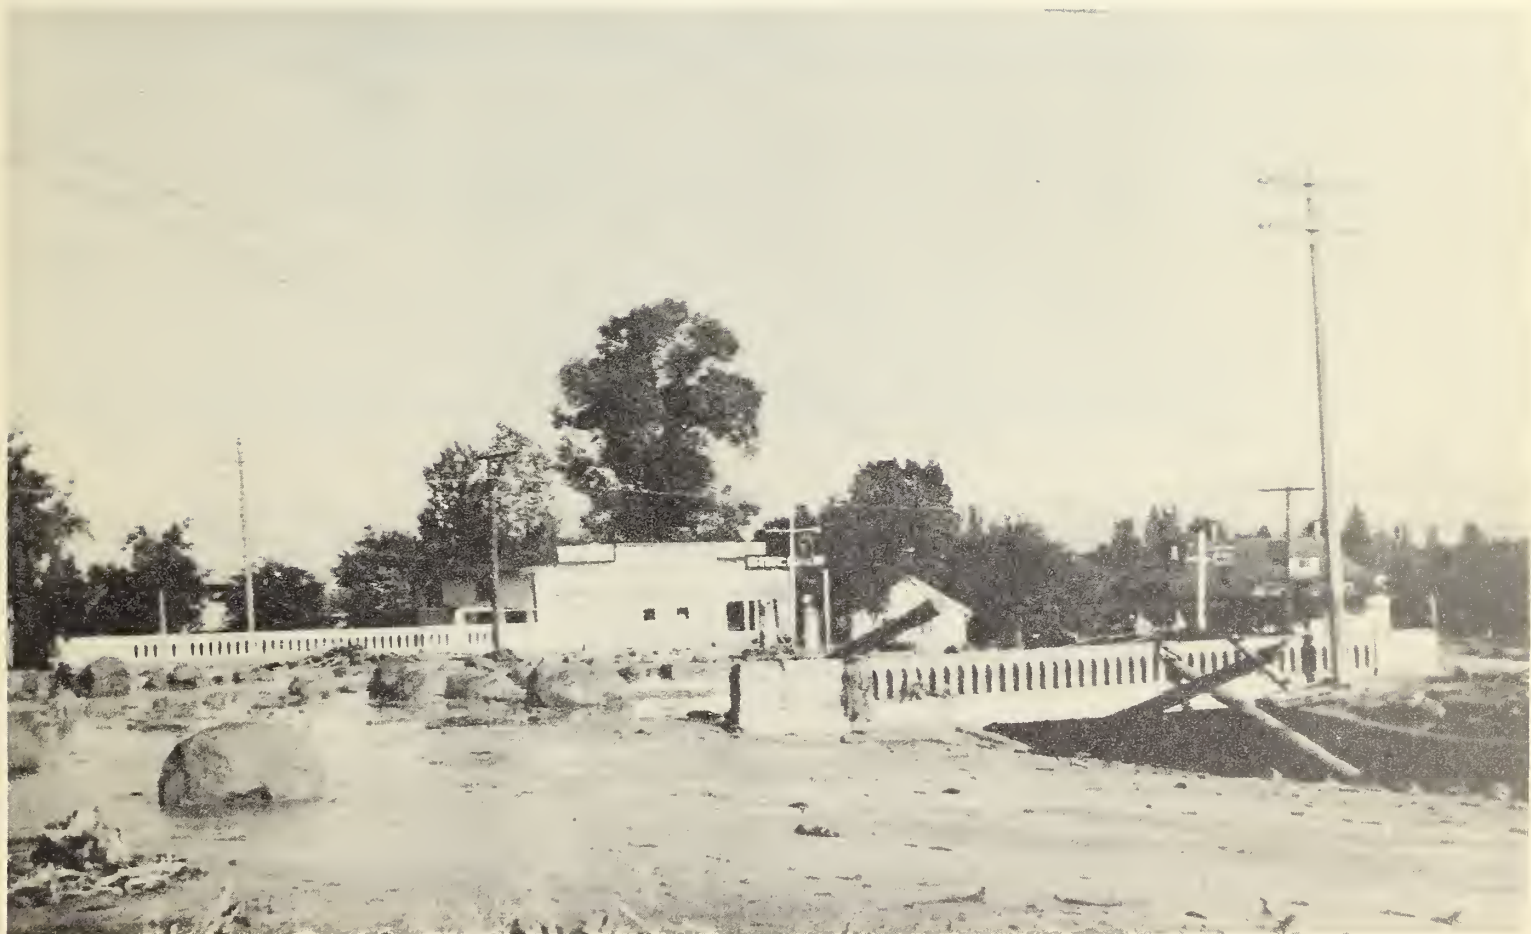
A MUD - ROCK FLOOD HIT MT. PLEASANT.

This, the most disastrous flood of all, originated high on the mountain above the town. Rain fell at a high rate on overgrazed lands for about one hour. This was not freakish intensity for summer storms in the Mt. Pleasant area, but hitting as it did on bare headwater lands, it:

FILLED BASEMENTS OF BUSINESS HOUSES AND HOMES WITH MUD.
DEPOSITED THICK MUD, ROCKS AND BOULDERS ON 50 ACRES OF
LAWNS, PARKINGS AND GARDENS INSIDE MT. PLEASANT CITY
LIMITS AND ON 100 ACRES OF FARMLAND - IN PLACES 4 FEET
DEEP.

Careless burning and overcutting of timber also contributed. Vegetation removed from slopes above Mt. Pleasant was never replaced. Rebuilding the waterholding power of the mountains above town will require removal of livestock from the critical areas for an indefinite period. Contouring and revegetation will also be necessary.

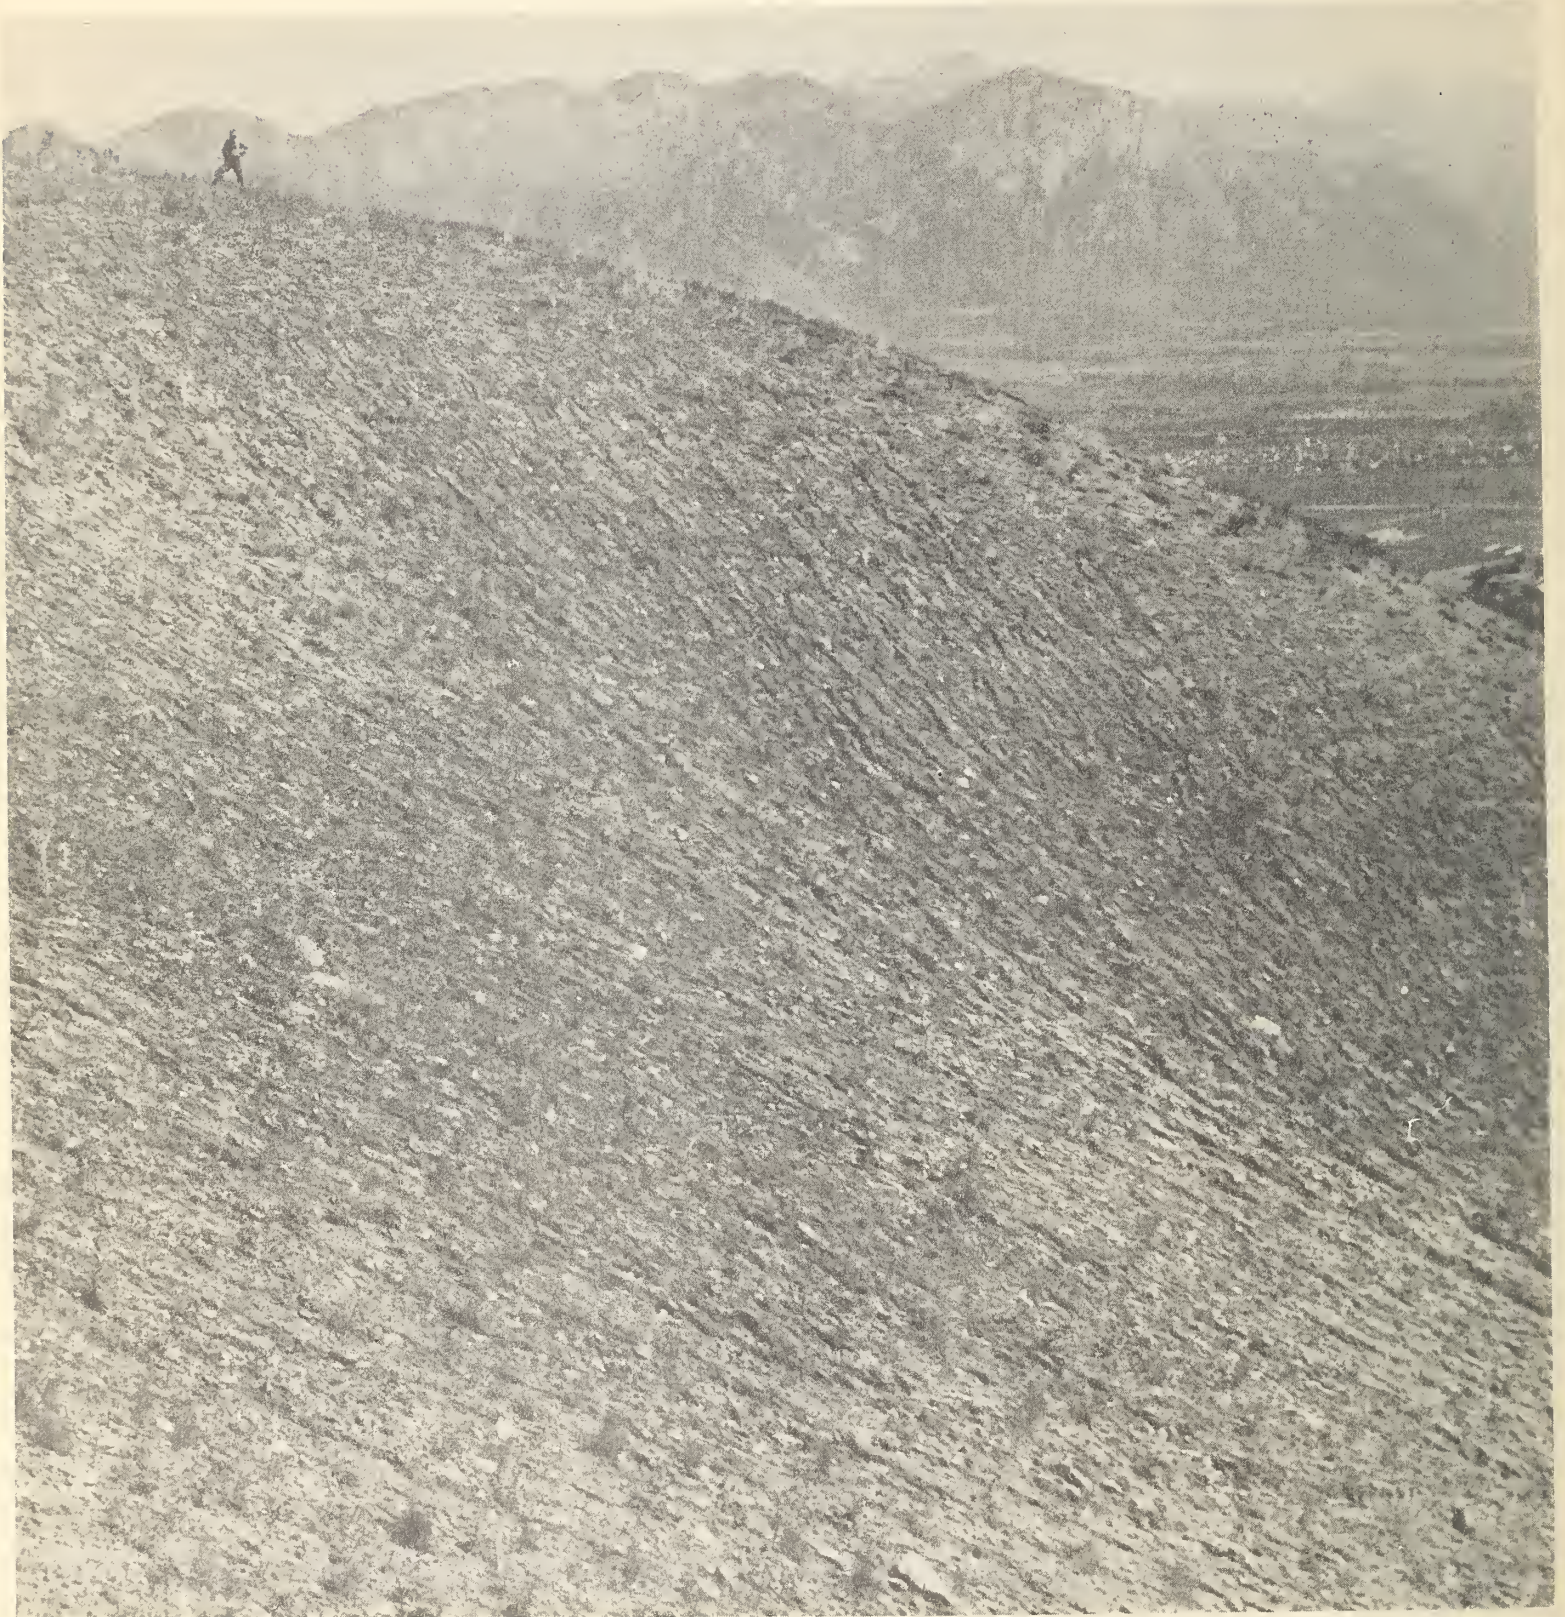
FUNNEL FOR FLOODS.

In the early days, perennial grasses on the steep slopes above Salt Lake City were overgrazed and gradually replaced by cheatgrass, a highly inflammable annual. Repeated fires through the years burned the remaining shrubs as well as the cheatgrass.

On July 31, 1944, a match carelessly dropped in the cheatgrass started a flash fire which laid bare 600 acres of steep land before it could be controlled.

The hazard still exists. Safety can be attained only through contour trenching, reseeding, emergency debris basins, and intensified fire protection.

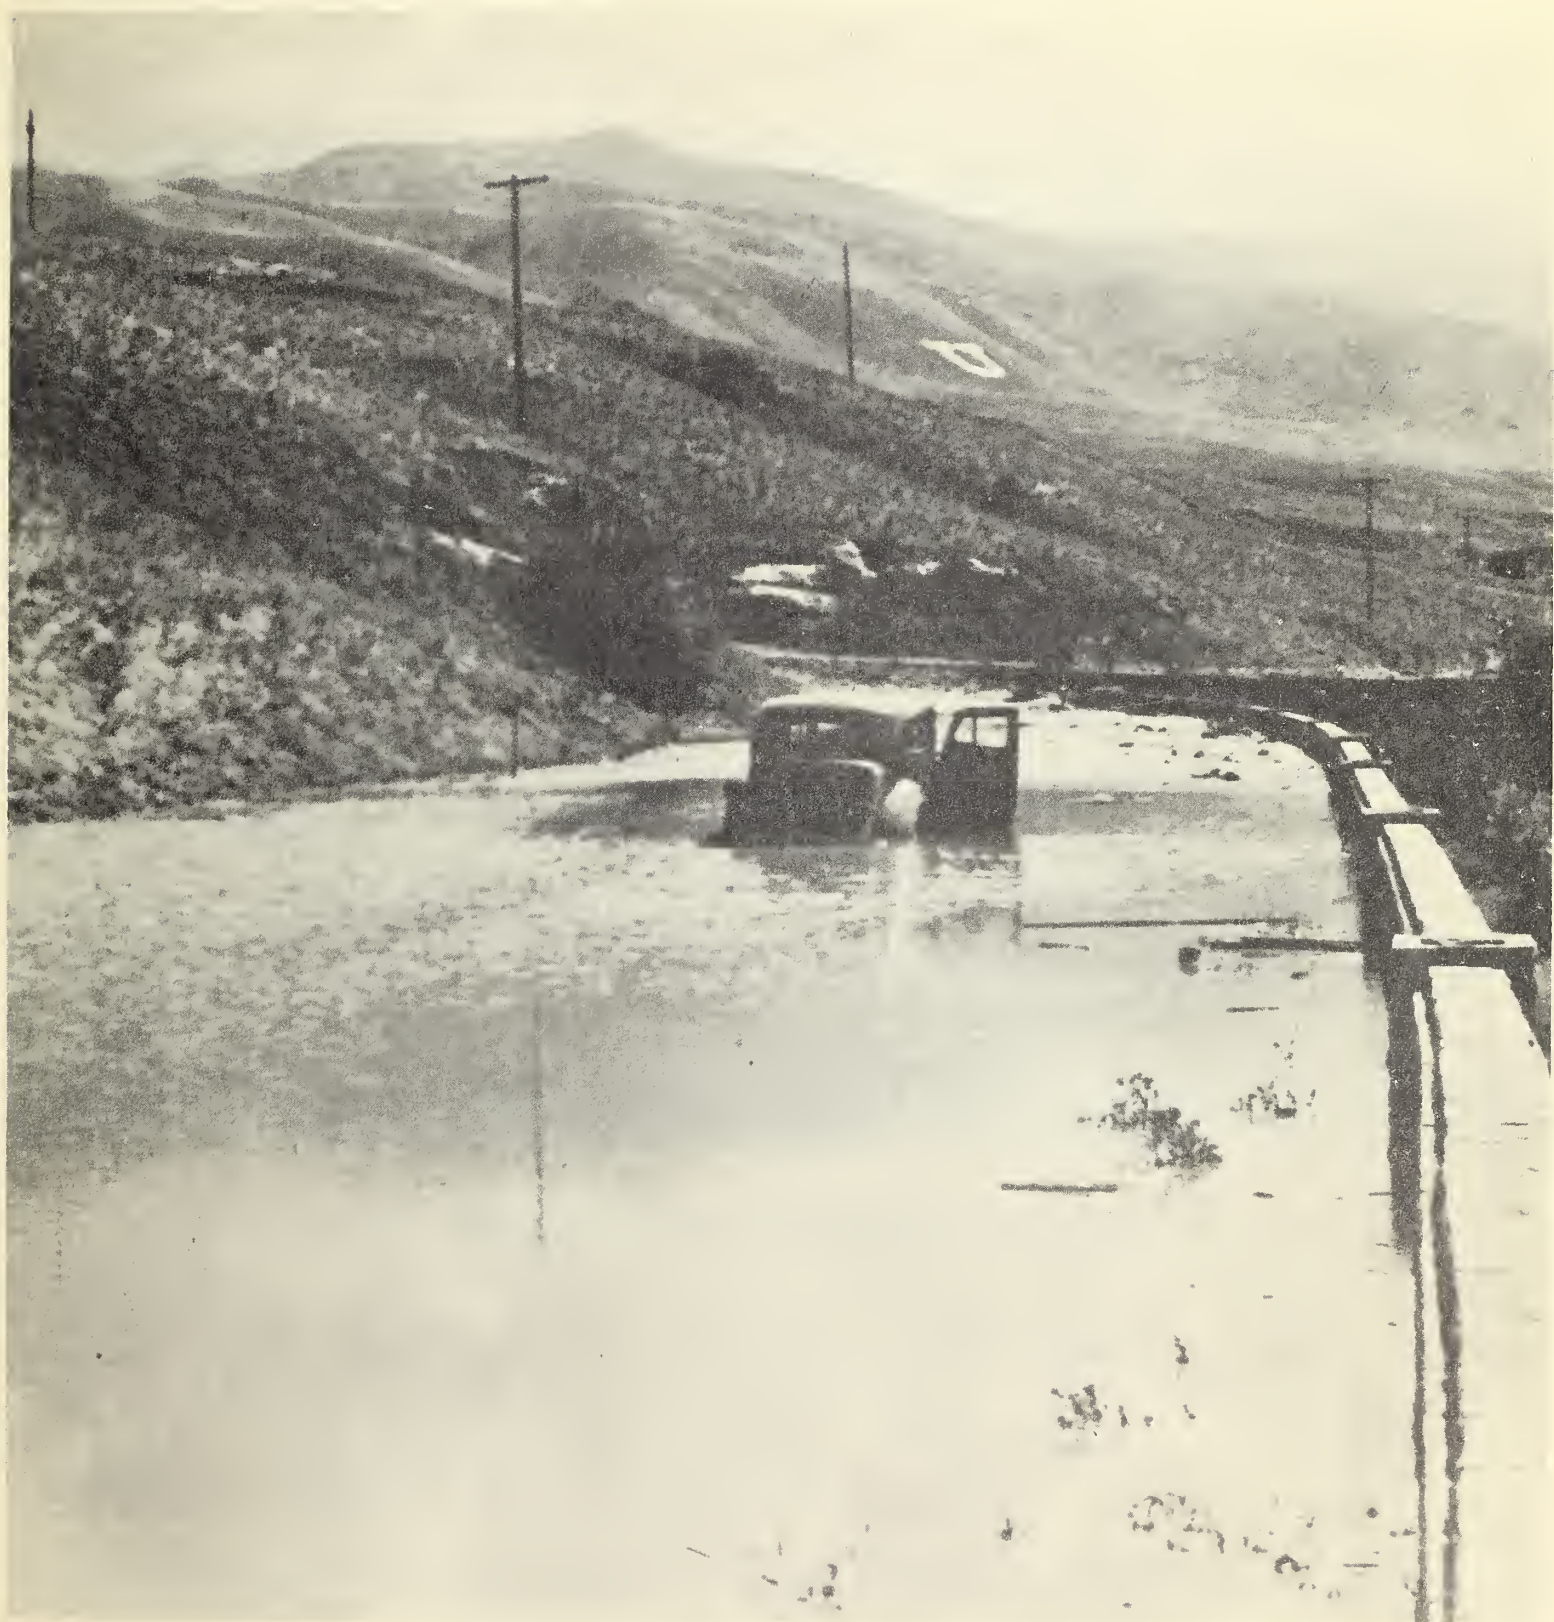
WASATCH BOULEVARD.

On August 19 of the following year, an intense rain-storm struck these fire-denuded slopes. A flood which caused \$346,000 damage swept down. Headstones were overturned and caskets washed out of graves where the flood crossed the City Cemetery.

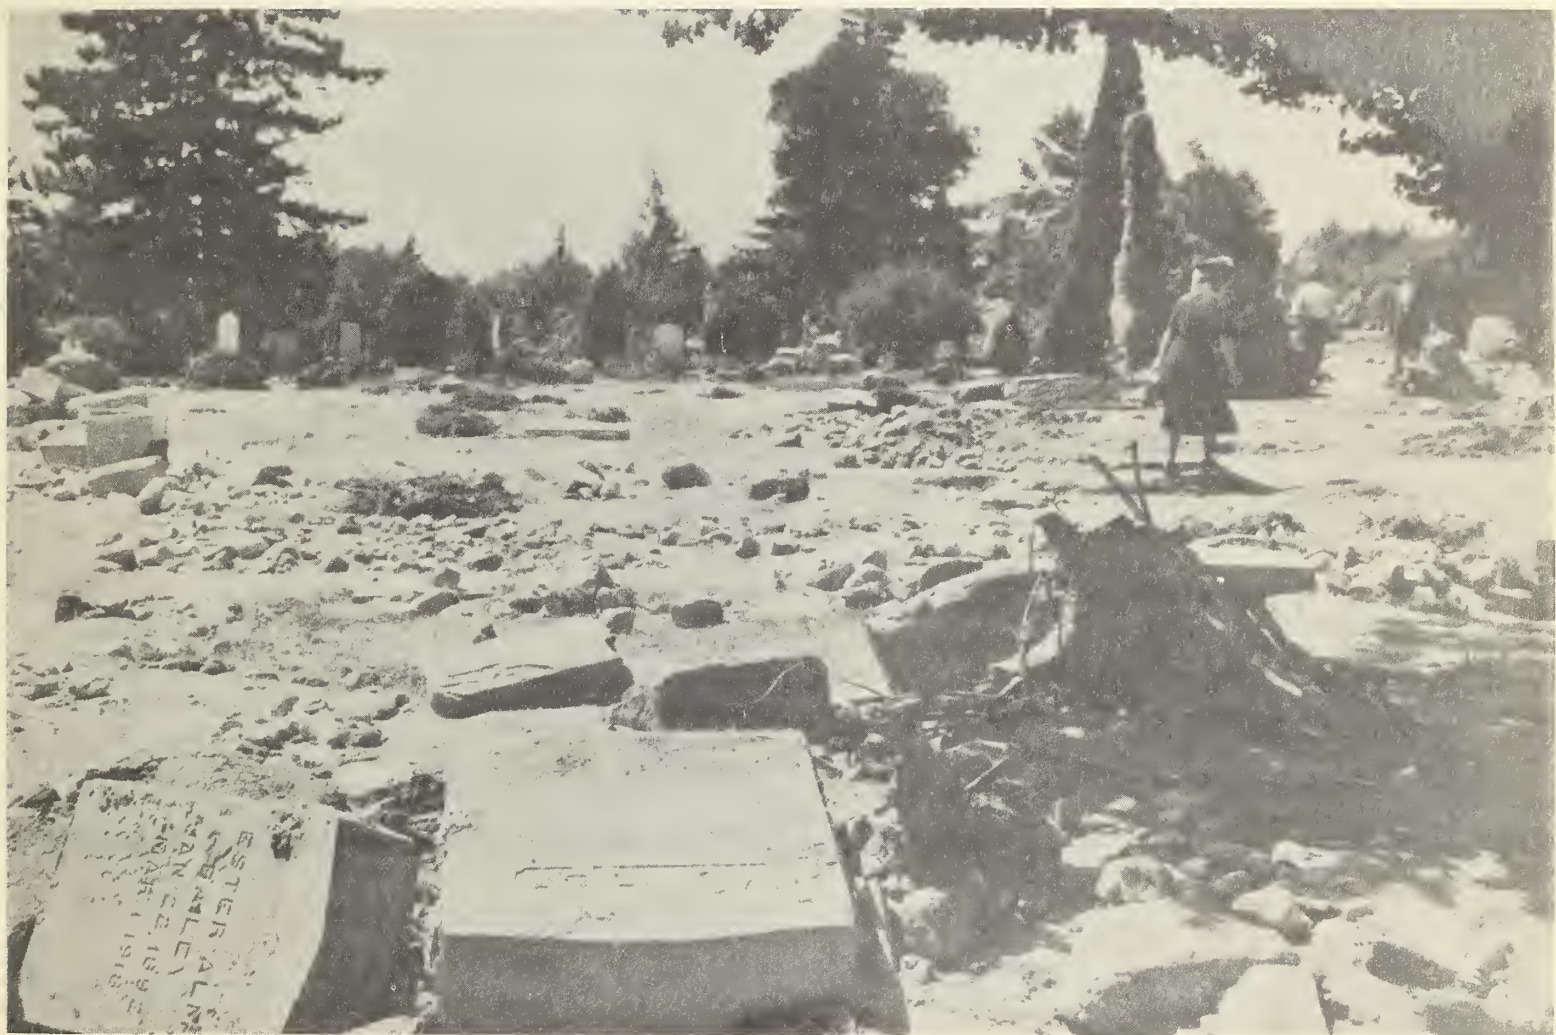
SALT LAKE CITY CEMETERY - SORROWS RENEWED.

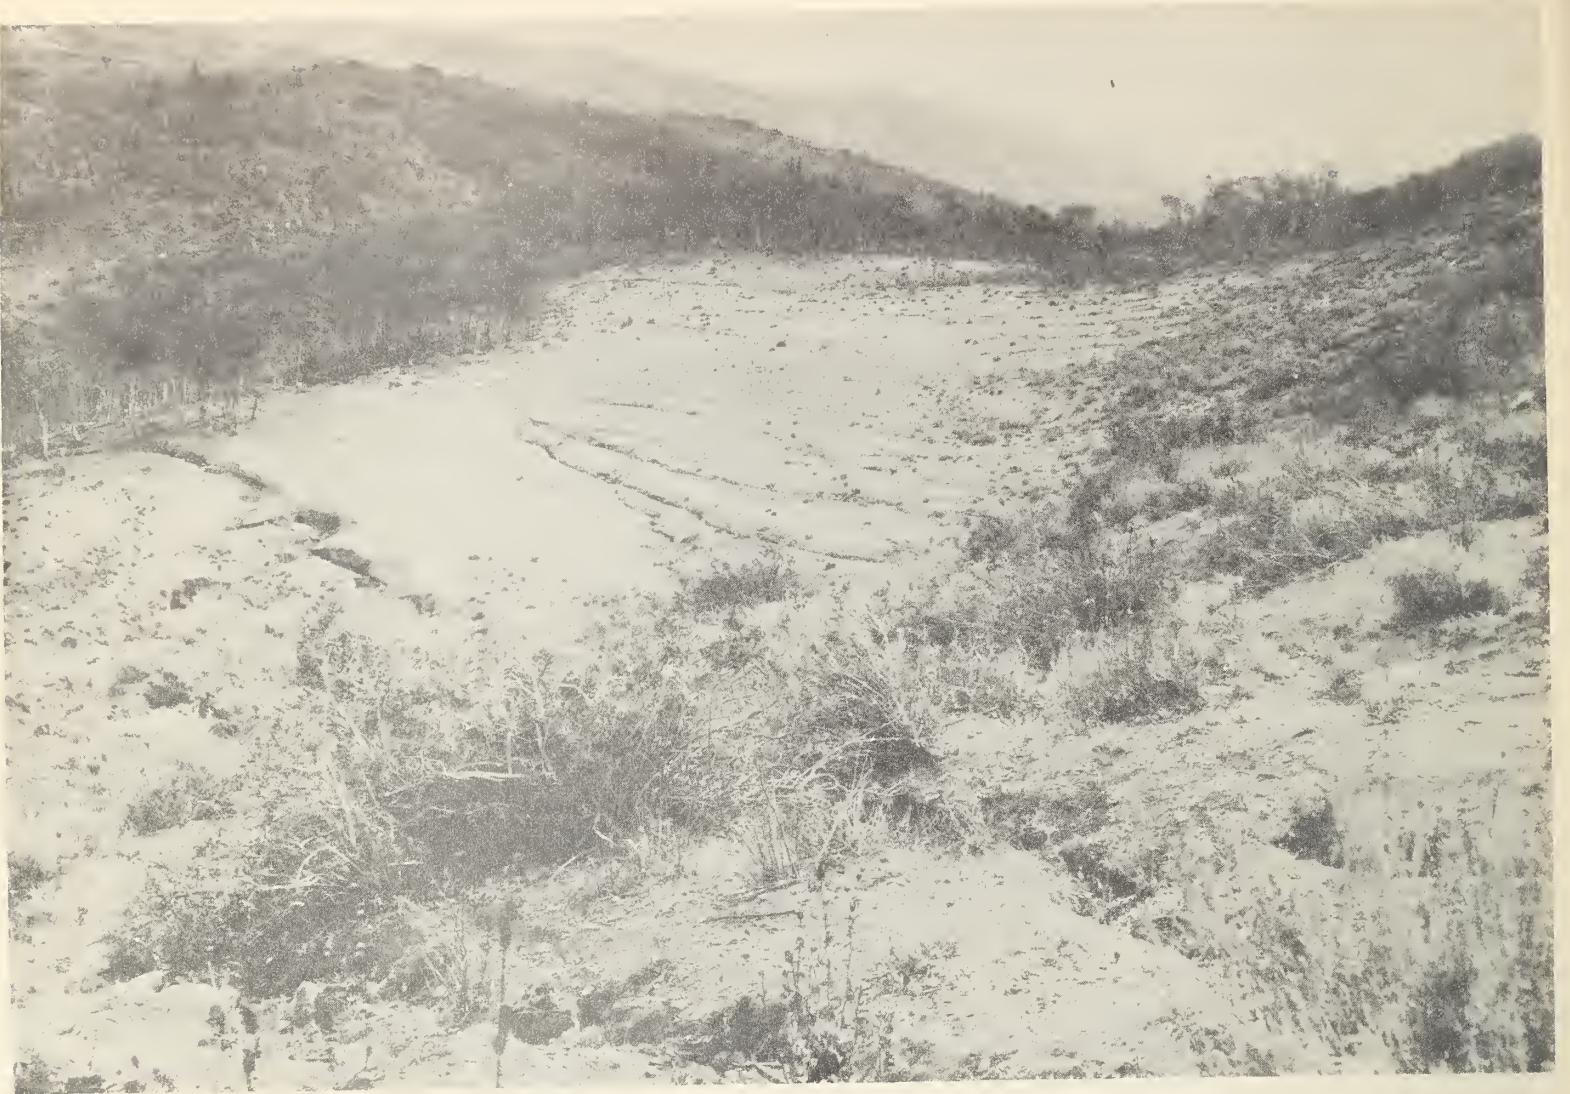
PARRISH CREEK HEADWATERS.

Davis County watershed lands in private ownership had been severely overgrazed and carelessly burned for several decades. Floods during the 20's aroused people living close to the mouths of the canyons. With the terrible mud-rock flood of 1930, fright and indignation among the valley dwellers reached a peak. Private watershed holdings on which the floods originated were purchased at a cost of \$39,000.00 and placed in public ownership. About \$60,000.00 more was spent for other adjacent private lands declining in plant cover and needing protection. All grazing was eliminated indefinitely from critical headwater areas and strict fire control measures clamped down. About a quarter million dollars then went into contour trenching, emergency debris basins, and reseeding.

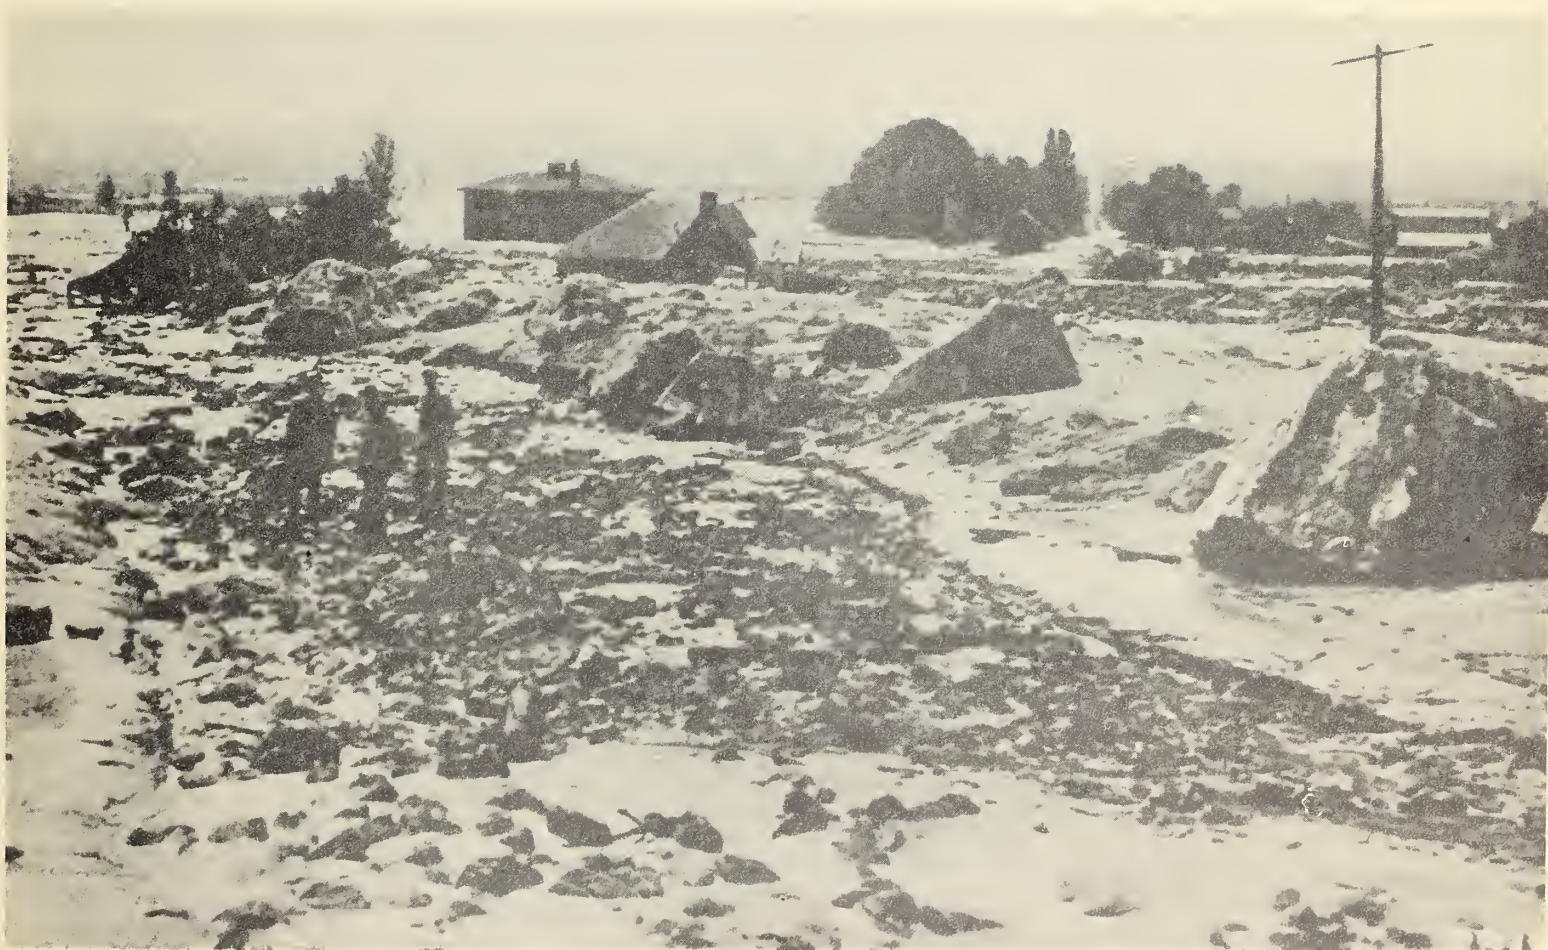
SCHOOL FLOODED OUT ! CLASS DISMISSED.

TOOK SIX LIVES.
WRECKED SEVEN SUBSTANTIAL HOMES AND DAMAGED OTHERS.
SERIOUSLY DAMAGED A LARGE SCHOOL.
DAMAGED WATER AND IRRIGATION SYSTEMS.
BLOCKED ROADS, RESULTING IN INTERRUPTED TRANSPORTATION
AND HEAVY REPAIR COSTS.
COVERED VALUABLE FARM AND ORCHARD LAND WITH GRAVEL,
ROCKS, AND BOULDERS.
SERIOUSLY DEPRECIATED PROPERTY VALUES THROUGHOUT THE
FLOOD-STRUCK AREA.
